Toward Accessible Listoric Streetscapes

A Study of New York City's Belgian Block Heritage

Prepared for the Historic Districts Council
April 2017

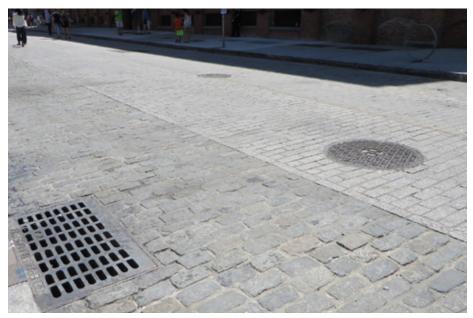
Figure 5: Washington Street's new center roadbed pavers (top) with historic Belgian block reset in the parking strip (foreground)

The Phase One project principally focused on Washington and Water streets and was completed in fall 2011. Drawing on the PDC-approved designs developed in the 1980s, the project reset historic Belgian block within the roadbed on Water Street and in some portions of Washington Street. However, in the center roadbed of Washington Street, the existing Belgian blocks were replaced with a wide strip of new, flat-topped granite blocks treated with a thermal finish to provide slip resistance (Figures 5 & 6). This new granite strip was flanked by historic Belgian blocks reinstalled in the parking lanes on either side.

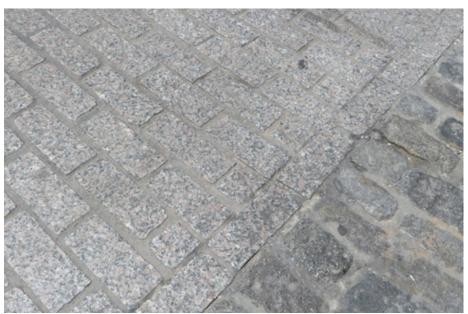
Figure 6: Washington Street center roadbed detail

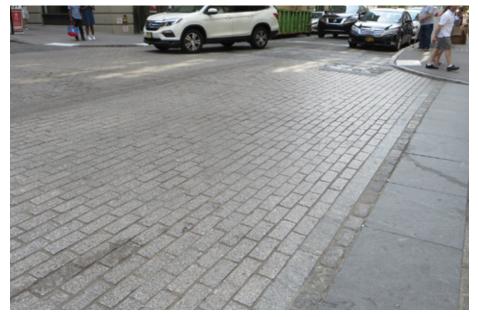
Figure 7: Front Street at Washington Street, showing new granite blocks installed within the interior of the intersection

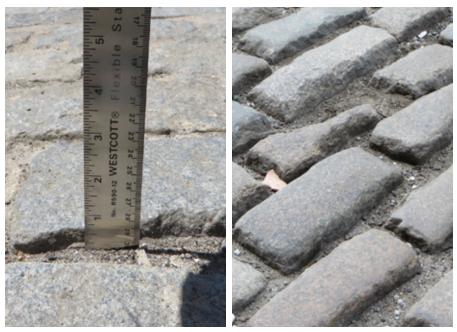
Figure 9: DUMBO's typical Belgian blocks

However, the irregular profile of Belgian blocks makes them challenging for accessibility. Because of their undulating shape, they often exceed the 1/4-inch vertical surface discontinuity standard. In addition, because the blocks vary in profile, it is difficult to lay them tightly enough together in such a way that transitions between blocks avoid non-compliant height variations and gaps. Like most historic granite pavements, these blocks are also not slip-resistant, particularly when wet, posing hazards to pedestrians and bicyclists. Due to these properties, most of DUMBO's Belgian blocks unfortunately cannot meet ADA standards for accessible routes.

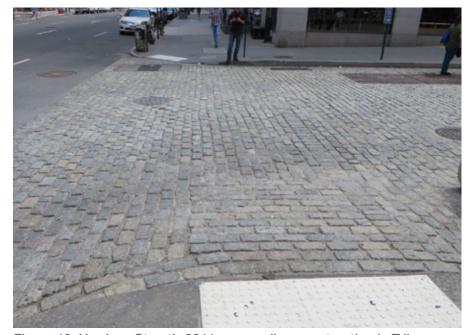
Figure 10: Harrison Street's 2011 crosswalk reconstruction in Tribeca

Elsewhere, efforts to meet accessibility standards using historic Belgian blocks have not, in our view, succeeded. On Harrison Street in Tribeca, for example, Belgian blocks were used at a crosswalk at Hudson Street reconstructed in 2011, including an unusual design where blocks ramp up to the curb elevation (Figure 10). While this is a laudable effort to resolve accessibility challenges, the crossing appears not to comply with ADA and Access Board standards due to the gaps between blocks and the varying surface elevations.

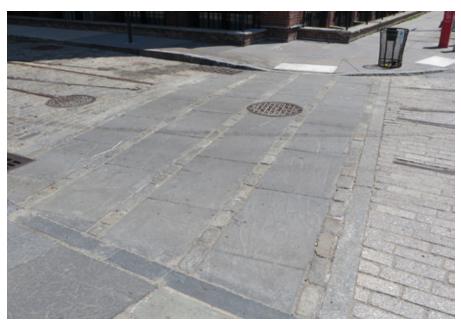
Figure 11: DUMBO's Phase One crosswalk design

Crosswalks constitute the accessible routes across streets at each intersection, creating connections to sidewalks, plazas, and other accessible pathways. The crosswalk developed for Phase One of the DUMBO street reconstruction (Figure 11) was developed by

consulting landscape architects Johansson & Walcavage. Drawing on historic research, the firm created a design using large, rectangular granite pavers separated by rows of smaller granite blocks. Historic photographs (Figure 12) show that this type of crosswalk was used extensively throughout New York City in the 19th and early 20th centuries, including in DUMBO. Indeed, in certain places within the historic district, granite slabs of this type are still extant, notably at intersections along Plymouth Street and within the sidewalk zone on Plymouth and Jay streets (Figure 13).

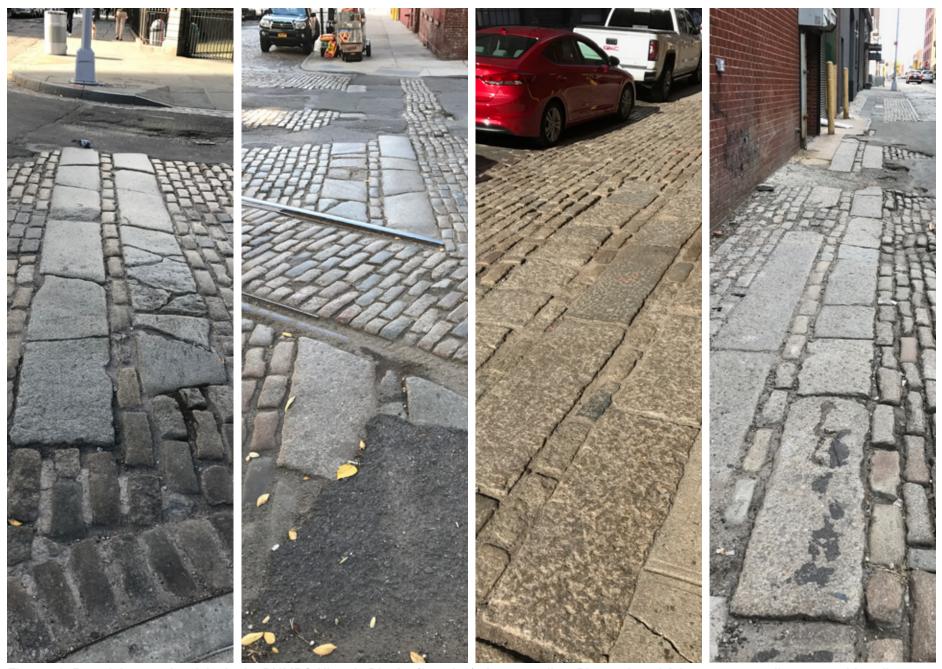
Figure 13: Remaining granite slabs in the DUMBO Historic District (from left): A crosswalk at Plymouth and Adams streets; rails cross a sidewalk at Plymouth Street and Anchorage Place; a three-banded sidewalk at Plymouth and Jay streets; a two-banded sidewalk on Plymouth near Jay Street.

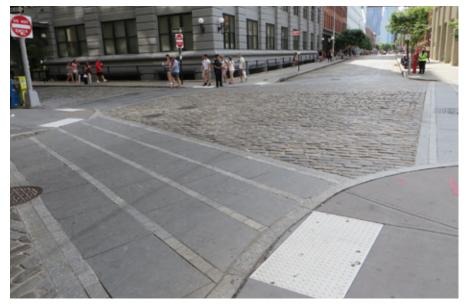
Figure 15: Irregular crosswalk geometry at Water and Main streets

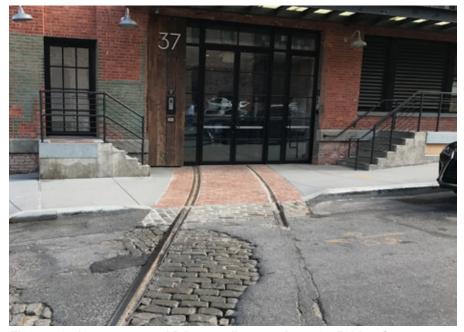
Figure 18: An attempt at ADA-compliant tracks at 37 Bridge Street

In spite of the challenges, it would be feasible to design treatments of rails and adjacent pavements that could meet ADA requirements. Indeed, the 2010 ADA standards permit flangeways of up to 2-1/2 inches at rail track crossings when necessary for the operation of trains across accessible routes. While it is not clear whether this exception would apply to inactive rail tracks, such an allowance should certainly be explored. Because existing conditions in locations where historic tracks and contemporary accessible routes intersect are so varied, design solutions must be adapted to each unique situation. A "toolkit" of available options might include partially filling flangeways to within 1/4 inch of the rail, so that the historic flangeway is still identifiable while meeting the ADA standard limiting change in vertical height.

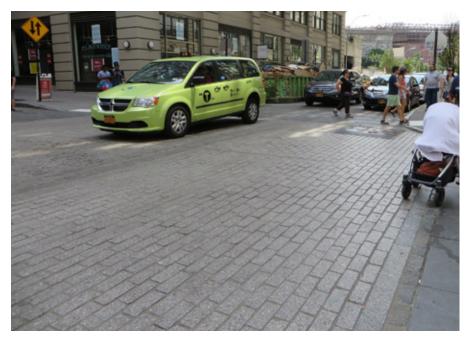
Figure 19: Phase One intersection with new thermal finish pavers at Front and Washington streets

A related concern regarding DUMBO's Belgian block streetscapes is the "box" in the center of intersections between crosswalks. As noted above, in the Phase One street reconstruction project, historic Belgian blocks were removed from this area at certain intersections, and replaced with new thermal finish granite pavers (Figure 19). The rationale for this design decision is not entirely clear, since the center of the intersection is not an accessible route. It can be speculated that filling the intersection with thermal finish pavers is considered preferable to carving up the center of the intersection with a jumble of materials where bikeways cross, particularly where two-way streets with bike lanes intersect. Other Phase One intersections were reconstructed with the existing Belgian blocks in a more historically sensitive treatment (Figure 20).

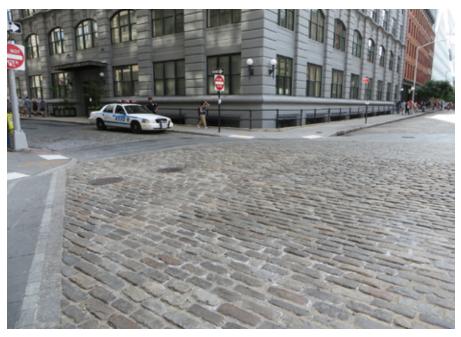
Figure 20: Alternate Phase One treatment retaining historic Belgian blocks within the intersection at Water and Main streets

walk slabs. We believe that closer examination of this treatment is advisable. All opportunities to retain the historic Belgian block in the center of these intersections should be considered to preserve as much historic fabric as possible. In addition, as recommended below, this issue should be discussed as part of an evaluation of citywide policy for historic streetscapes.

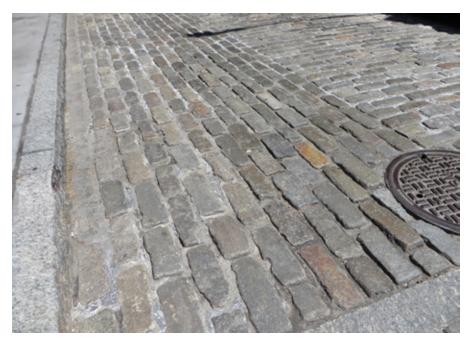
Figure 21: Phase One bikeway detail on Water Street

A compromise solution in Phase One was to use historic Belgian block pavers for the bikeway along Water Street, but to orient the blocks parallel to the curb, running in the direction of bicycle travel (Figure 21). As noted earlier, this solution altered the historic roadbed configuration but did not appear to improve rideability.

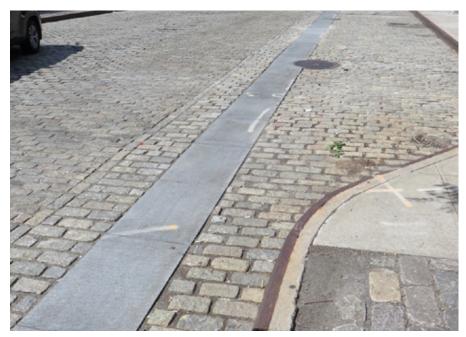
Figure 22: A bikeway on Varick Street in Tribeca, similar to the present proposed design for DUMBO's street reconstruction project

For subsequent project phases, NYCDOT has developed a new bikeway design using 2 1/2-foot-wide, 6-inch-thick granite slabs with a thermal finish, separated from the existing Belgian block roadbed by a granite header course (Figure 22). This detail was selected to provide a smooth riding surface and visually distinguish its modern surface from historic paving materials. Such a bikeway would appear to comport with NYCDOT's *Street Design Manual*, which notes, "Provision must be made for a smooth cycling surface, regardless of whether or not the roadway is part of a designated bike route. DOT and DDC are finalizing a new specification for achieving rideability." To date, NYCDOT has not confirmed whether this new specification has been released.

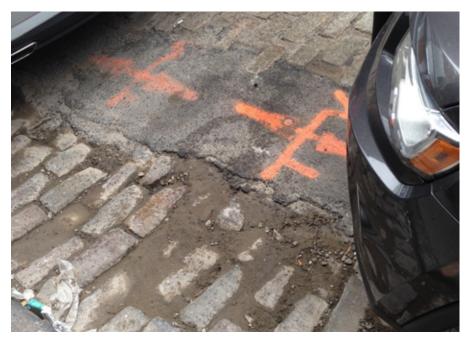
Figure 23: Asphalt patch and poorly reset Belgian blocks due to utility work in the roadbed

This description is almost entirely apt today. Abundant poorly patched or asphalt-covered utility cuts mar the DUMBO Historic District (Figure 23). In some cases a trencher appears to have been used to cut a line directly through roadbed blocks, a practice that should not be permitted due to the resulting unnecessary damage to the streetscape's historic fabric.

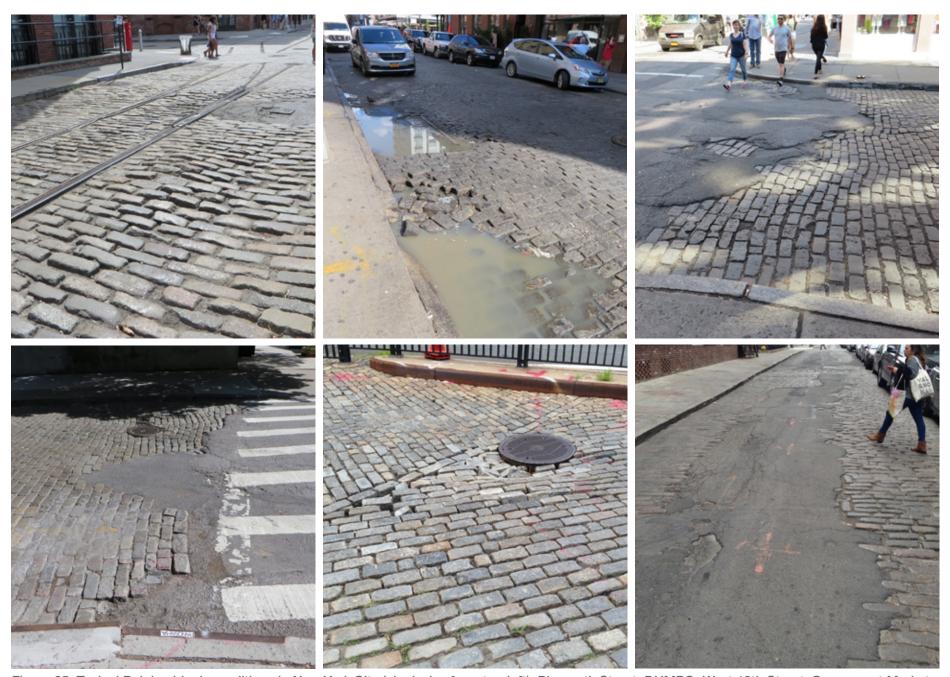
Figure 25: Typical Belgian block conditions in New York City (clockwise from top left): Plymouth Street, DUMBO; West 13th Street, Gansevoort Market Historic District; Wooster Street, SoHo; Water Street, DUMBO; Vestry Street, Tribeca; Perry Street, Greenwich Village.

A look at the Belgian block streets of DUMBO, SoHo, or Greenwich Village reveals streetscapes in urgent need of repair (Figure 25). Not only do these streets require routine maintenance to protect their historic elements from degradation, but the proper care and upkeep of unit pavement and other historic street features is essential for keeping them accessible to all.

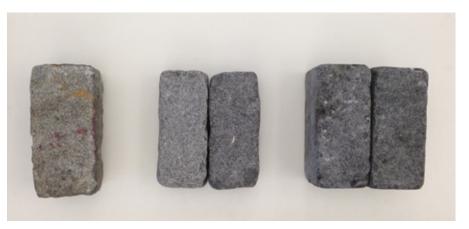
Figure 27: A historic Belgian block from the Gansevoort Market reconstruction project (left), with new, accessible alternatives.

The Gansevoort district's strategy of careful grading and reuse offers a promising approach that could potentially be employed in other historic districts. However, reuse of any blocks within accessible routes is contingent upon finding sufficient quantities that meet the tight ADA smoothness tolerances.

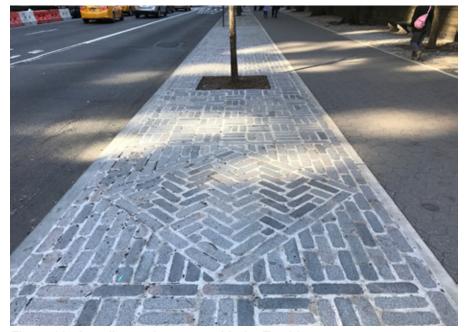
Figure 29: An adjacent bus stop with the Tumblestone pavers

- 4 inch x 13 inch x 3 inch deep thermal granite pavers
- 3/4-inch-wide mortar joints between pavers,

- mortared to within 1/4 inch of the finished grade of the stone
- 1 inch mortar setting bed
- 5 inch reinforced concrete subslab
